GEOTECHNICAL ENGINEERING REPORT

COLLEGE GREEN SINKHOLE REMEDIATION GREELEY, COLORADO

June 14, 2016

June 14, 2016 Project No. 16015-1

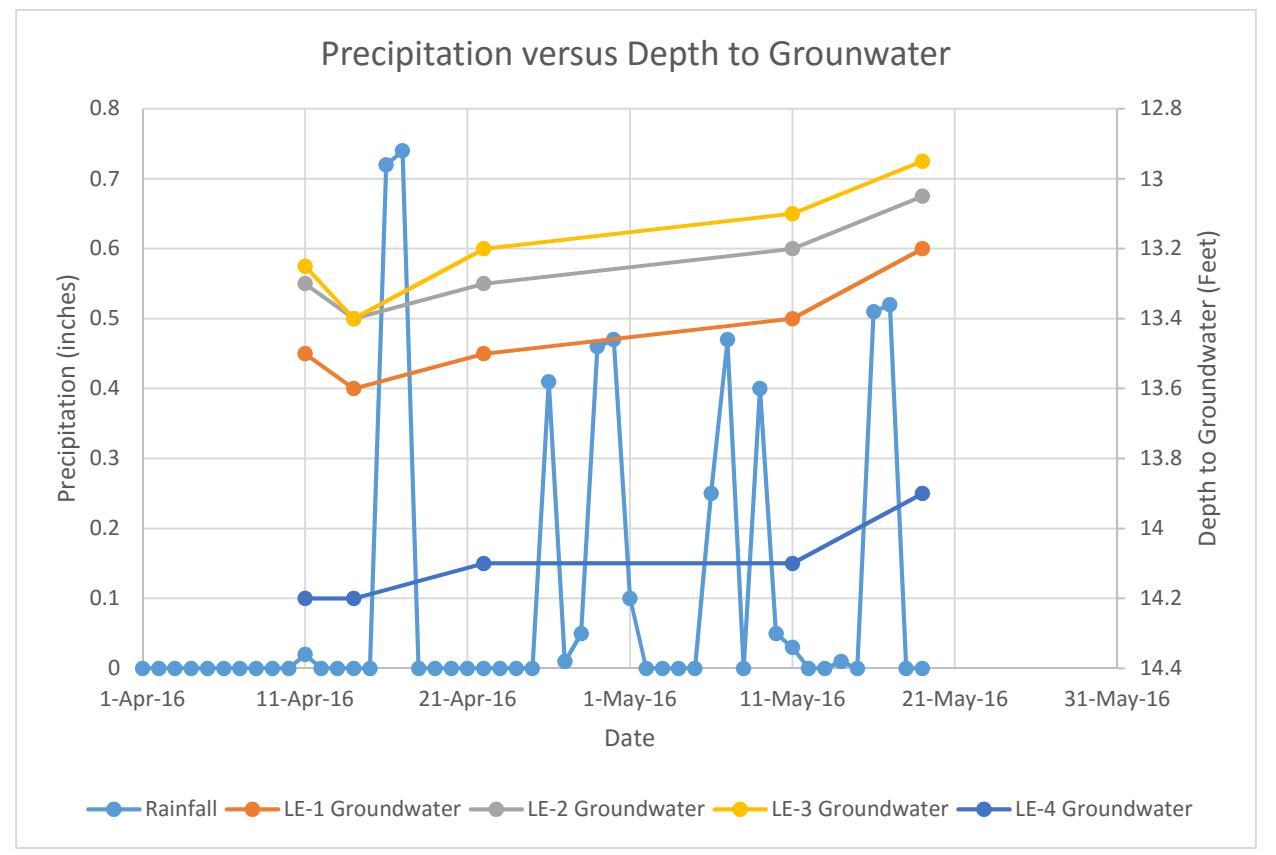
The graph below shows the groundwater levels compared to precipitation events during the same time period. While it appears that groundwater is generally rising, as would be expected during late spring, there does not appear to be a correlation between groundwater levels and precipitation events. Were the sinkholes directly related to groundwater fluctuations, we would expect to see a significant reaction of the groundwater table shortly after a precipitation event. As discussed below in Section 5, we believe the sinkholes are generally independent to groundwater, and more closely related to surface water infiltration.

Precipitation data from U.S. Climate Data website for Greeley, Colorado
