COLORADO CULTURAL RESOURCES INVENTORY

Greeley 8th Avenue Survey

Historical and Architectural Reconnaissance Form

4. Street Address: **1012 8th Avenue**
5. Municipality: **Greeley, Colorado**
6. County: **Weld**
7. USGS Quad (7.5’): **Greeley, Colorado** year: **1950** **Photorevised 1980**
8. Parcel Number: **096105336018**
9. Parcel Information: Lot(s): **7** Block: **78** Addition: **Greeley Original Townsite**
10. Acreage: **< 1**
11. PLSS information: Principal Meridian: **6th** Township: **5 North** Range: **65 West**
SE¼ SW¼ SE¼ SW¼ of section **5**
12. Location Coordinates: **Zone 13** **526257 mE** **4474626 mN**
Datum: NAD83

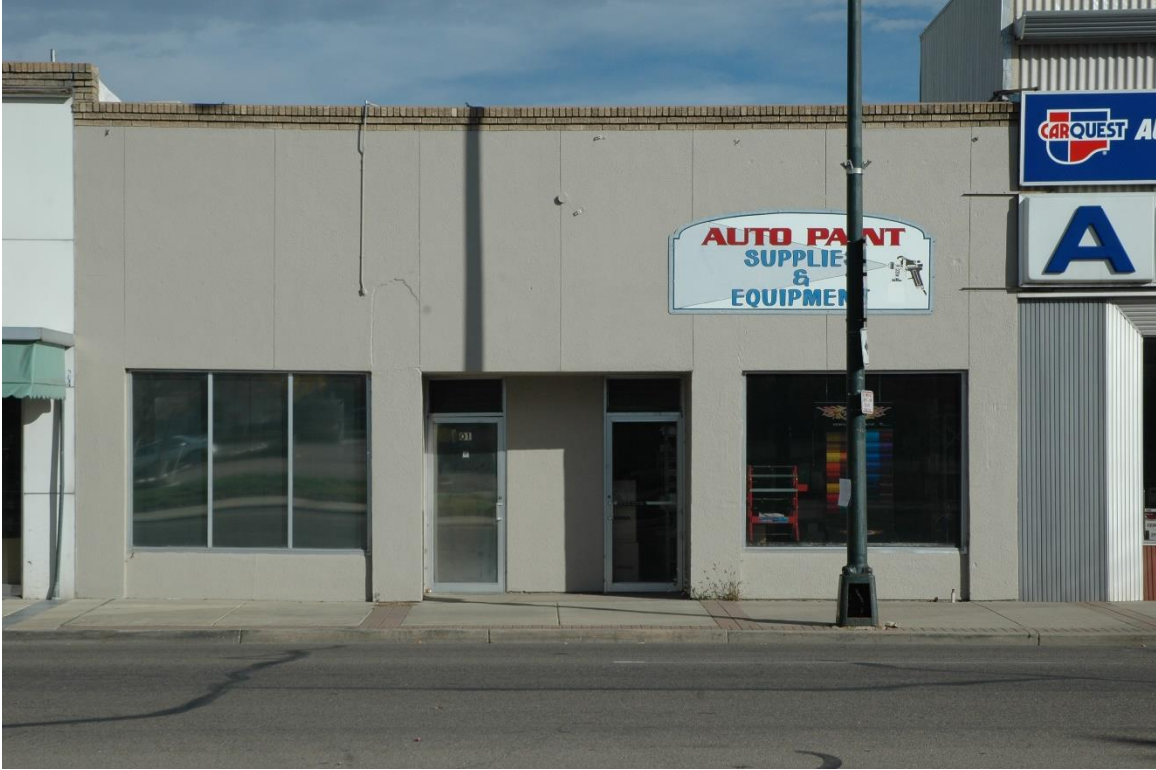
CD 1, Image 137 View to east of façade (west)

- Walls: **The west (façade) wall and the east (rear) wall are clad with pale beige color stucco over brown brick wall construction. Three courses of brown brick are exposed at the top of the parapet on the façade. A sign fastened to the upper façade wall advertises: "AUTO PAINT SUPPLIES & EQUIPMENT"**

- Windows: **The symmetrical façade contains a centered recessed entryway, with two glass-in-silver-metal-frame doors. The entryway is flanked on either side by large fixed-pane windows in silver metal frames.**

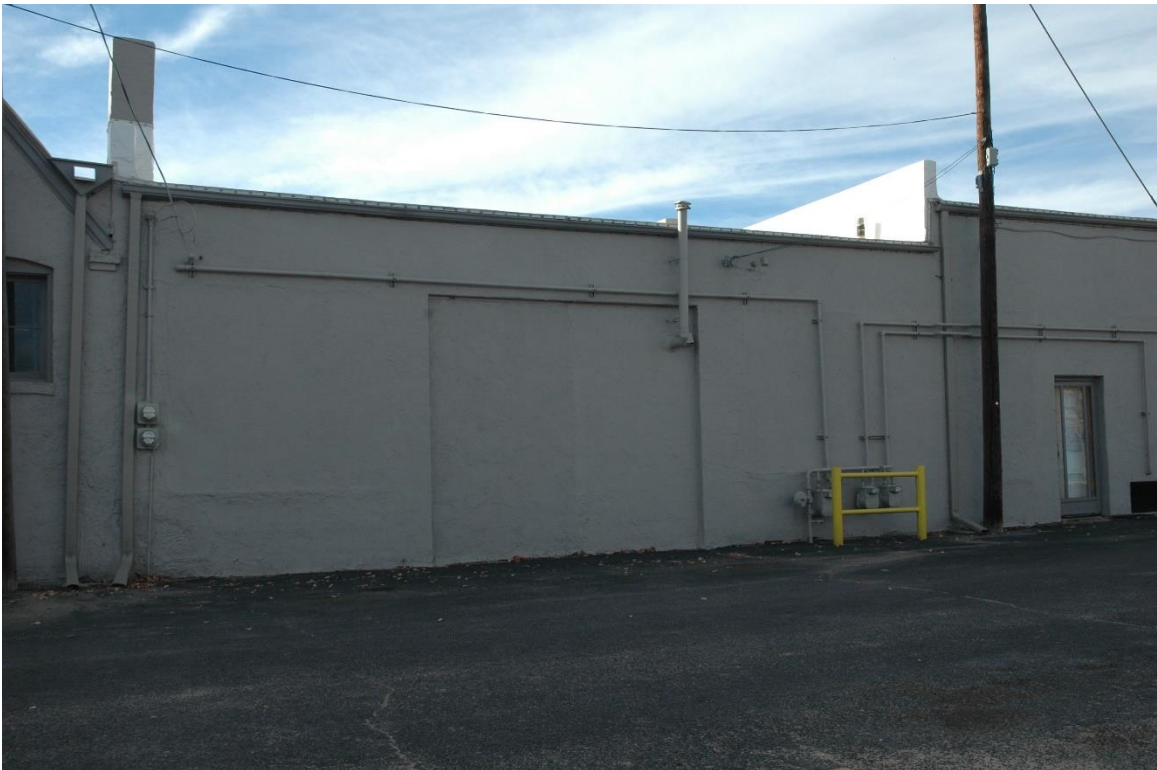
CD 1, Image 147, View to west of rear (east)

- Porch(s) / Doors: **The symmetrical façade contains a centered recessed entryway, with two glass-in-silver-metal-frame doors. The entryway is flanked on either side by large fixed-pane windows in silver metal frames. A former garage door opening on the east elevation has been filled in and covered with pale beige color stucco.**
