COLORADO CULTURAL RESOURCES INVENTORY

Greeley 8th Avenue Survey

Historical and Architectural Reconnaissance Form

- Street Address: **1212 8th Avenue**
- Municipality: **Greeley, Colorado**
- County: **Weld**
- USGS Quad (7.5'): **Greeley, Colorado** year: **1950** **Photorevised 1980**
- Parcel Number: **096108211002**
- Parcel Information: Lot(s): **4** Block: **98** Addition: **Greeley Original Townsite**
- Acreage: **< 1**
- PLSS information: Principal Meridian: **6th** Township: **5 North** Range: **65 West**
NE¹/₄ SW¹/₄ NE¹/₄ NW¹/₄ of section **8**
- Location Coordinates: **Zone 13** **526251 mE** **4474307 mN**
Datum: **NAD83**

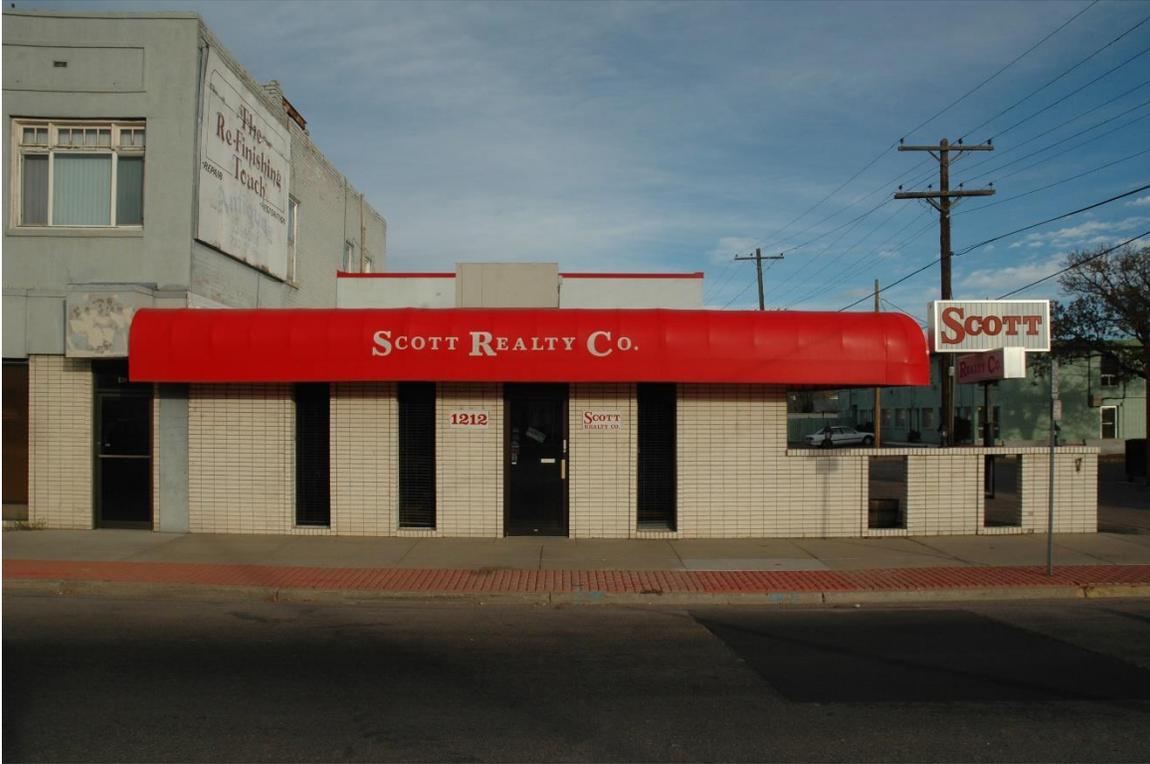
Walls: **The façade wall, facing 8th Avenue, is composed of a veneer of pale beige color bricks laid in stack bond. The south (side) wall and east (rear) wall are clad with pale grey color stucco. A red plastic awning over a metal frame extends along the**

full length of the upper façade, and wraps around to cover the west end of the upper south elevation. The awning features signage advertising “SCOTT REALTY Co.” in white letters on the red background.

- Windows: The façade contains three vertically oriented, floor-to-ceiling, fixed-pane windows, two north of the entry door and one south of the entry door. Seven similar windows, with brick surrounds, are located on the south elevation. The east (rear) elevation contains a 12-light industrial sash window.
- Roof: The building is one story in height, with a flat roof; however, the rear section is somewhat higher, and features a flat parapet on the west, and stepped parapets on the north and south sides. A red coping band extends around the top of the parapets.
- Chimney(s): N/A
- Porch(s) / Doors: A glass-in-metal-frame door, with a transom light, enters the façade. A painted grey wood door enters the south elevation.

CD 1, Image 199, View to East of facade (west)

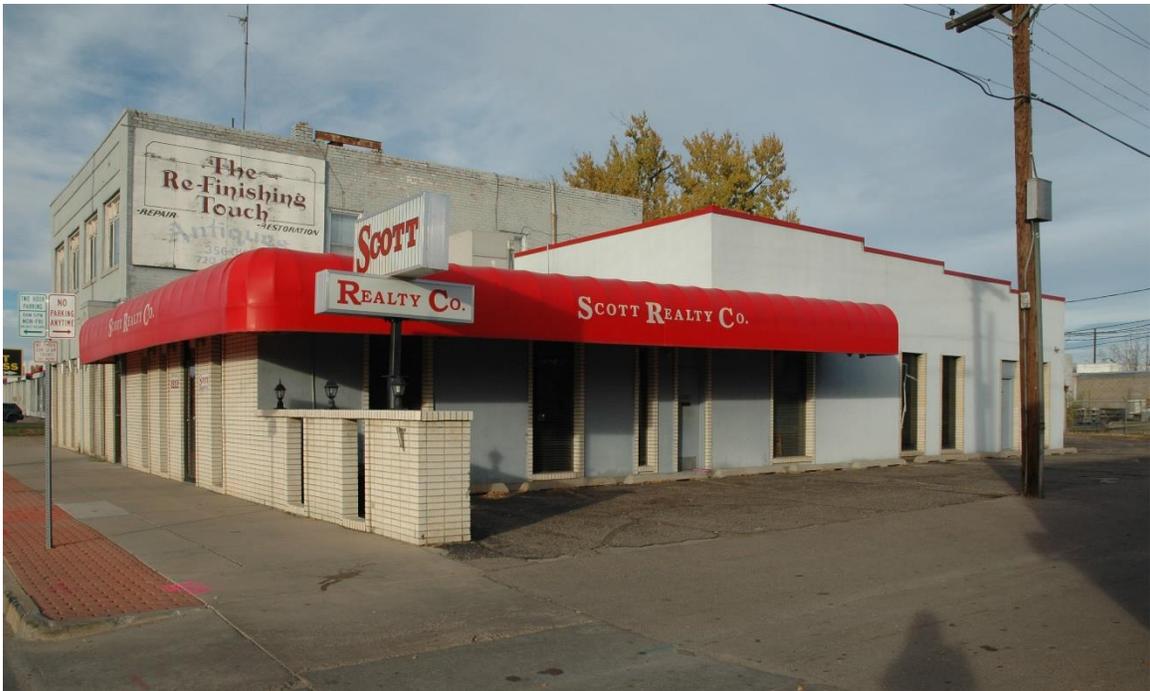
to the east. The building’s exterior has been significantly altered in recent decades so that it has lost much of its historic physical integrity.

CD 1, Image 200, View to NNE (of façade (west) and south side)

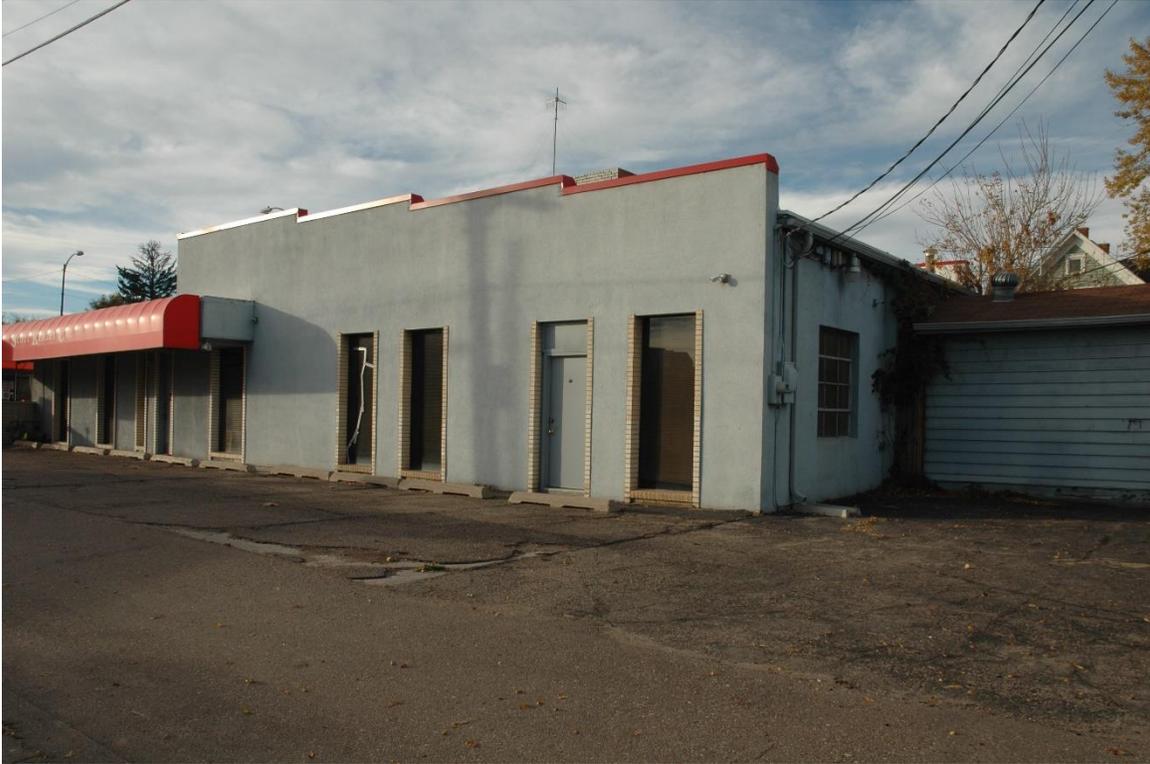
CD 1, Image 201, View to NW of south side and south end of rear (east)

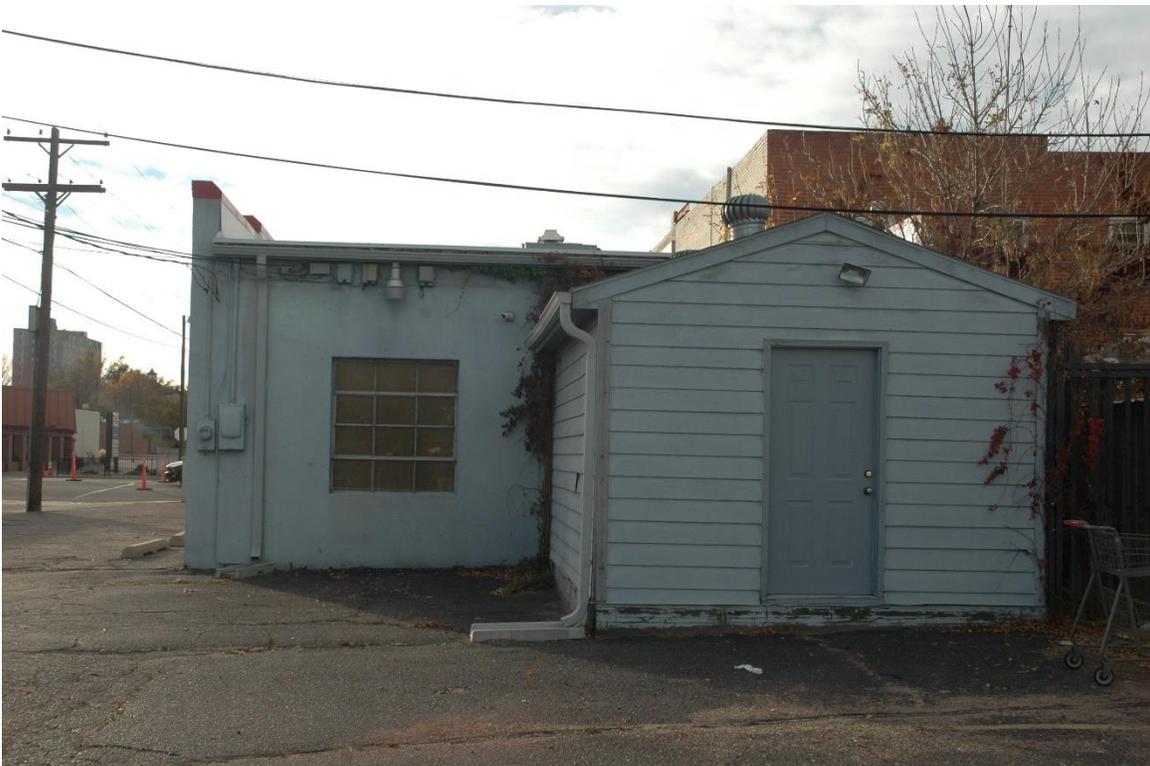
A storage shed, which measures approximately 10’ N-S by 16’ E-W, is located adjacent to the main building’s east (rear) elevation. Its exterior walls are clad with painted grey horizontal wood siding, and it is covered by a gabled roof with brown asphalt composition shingles and with boxed eaves. A painted grey wood-paneled door enters the shed’s east elevation. There are no windows

CD 1, Image 202, View to West of rear (east)
