# COLORADO CULTURAL RESOURCES INVENTORY

## Greeley 8th Avenue Survey

### Historical and Architectural Reconnaissance Form

1. Current Property Name: **Canton Garden Restaurant**  
Historic Property Name **Newt's Drive In, A & P Drive In**
2. Resource Classification: **Building**
3. Ownership: **Private**  
Owner(s) contact info:

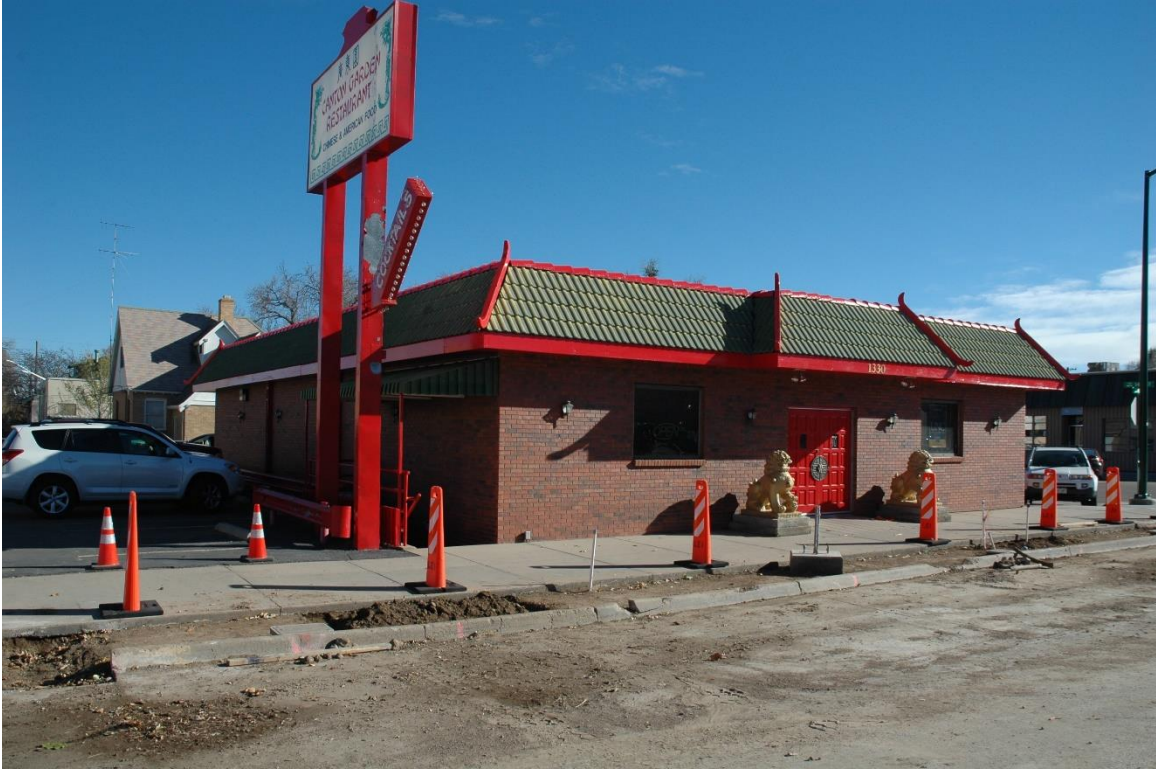
Windows: **The symmetrically arranged west-facing (façade) wall contains two single-light fixed-pane windows with brick rowlock sills. The south-facing wall contains two similar single-light fixed-pane windows with brick rowlock sills.**

Porch(s) / Doors: **The main entry into the building features a set of paired painted bright red wood-paneled doors located in the center of the west-facing (façade) wall. This doorway is covered by an extension of the roof eave and flanked by two golden Chinese guardian lions on concrete pedestals. The east-facing wall contains a painted bright red service door. A set of eleven concrete stairs descend to a painted bright red basement-level door at the south end of the east-facing elevation. A set of red brick or tile paved stairs descend to another painted bright red basement-level door at the west end of the north-facing elevation.**

CD 2, Image 11, View to SE of façade (west) and north side

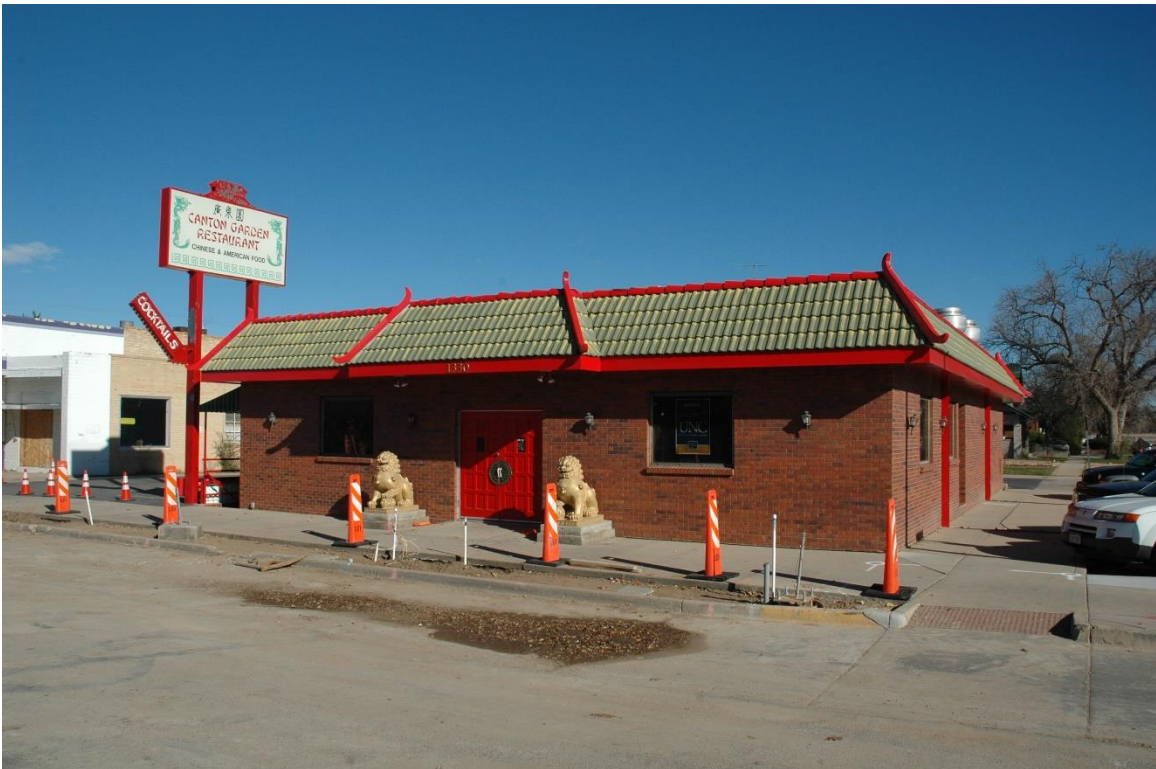
Roof: **The roof is flat, with decorative eaves which creates the appearance of a truncated hipped roof. The decorative eaves are clad with green clay tiles, with bright red accents and with a bright red soffit.**

CD 2, Image 12, View to ENE of façade (west)

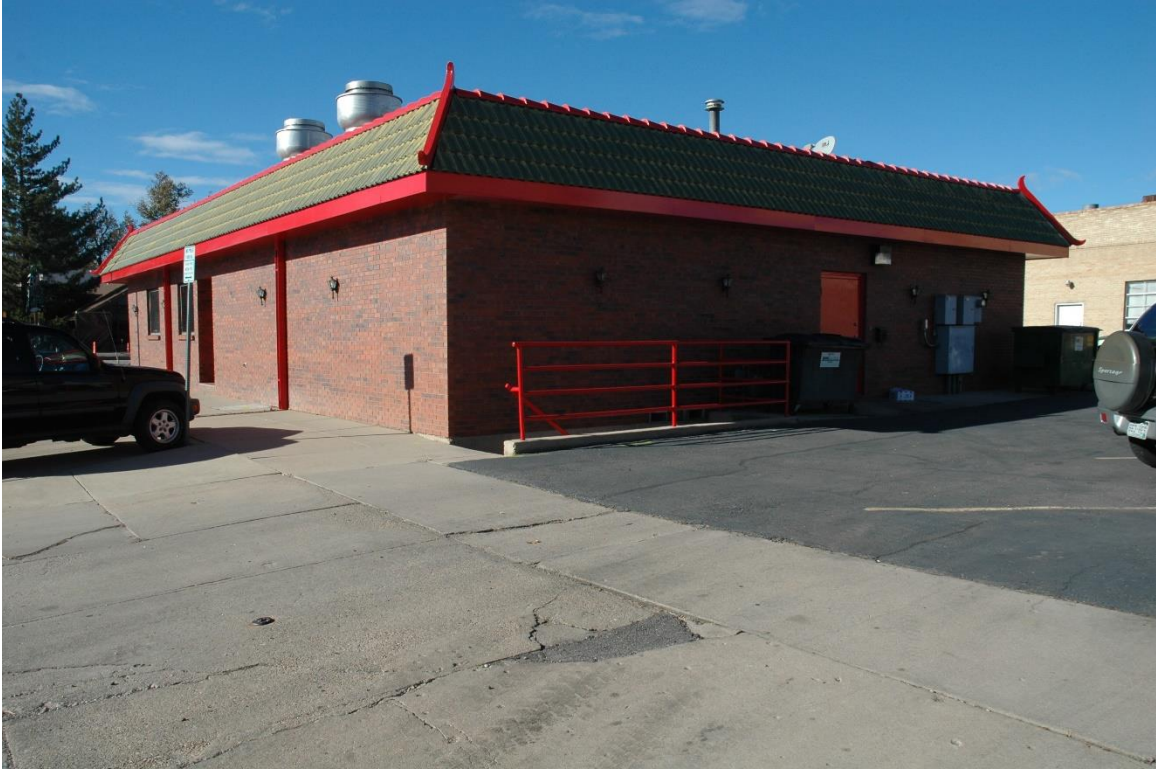
CD 2, Image 13, View to NW of south side and rear (east)

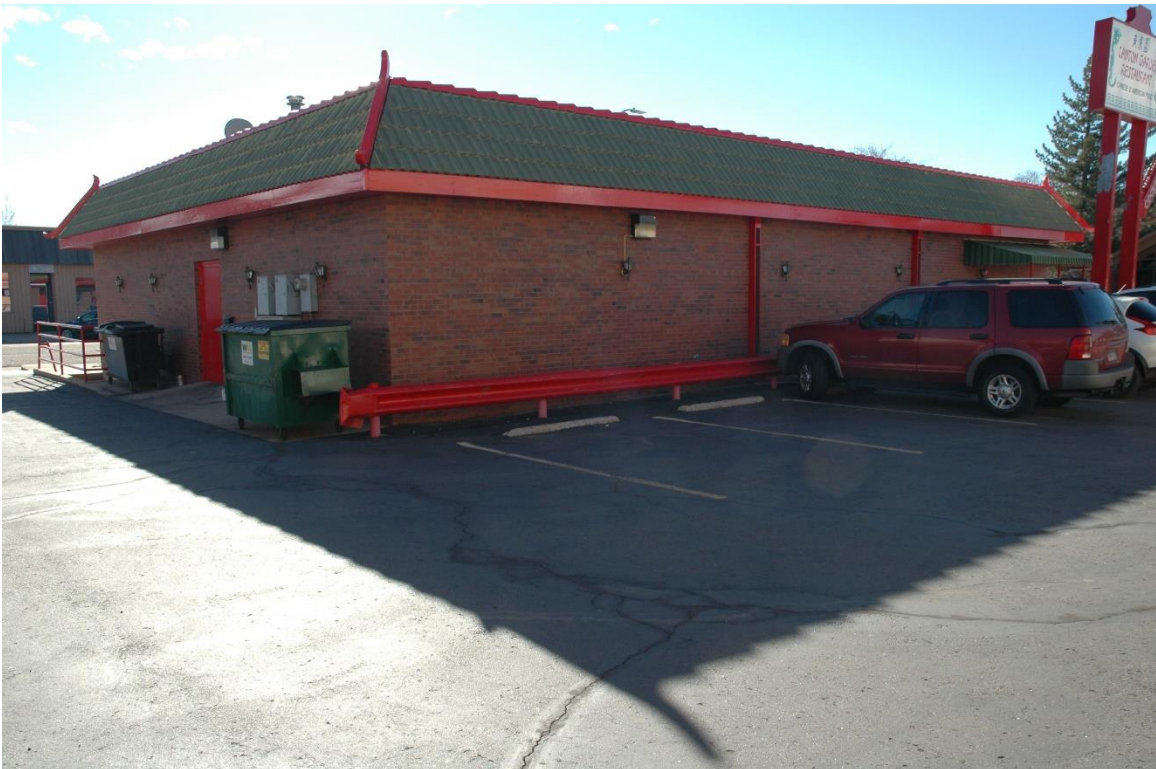
CD 2, Image 14, View to SW of rear (east) and north side
