COLORADO CULTURAL RESOURCE SURVEY

Architectural Inventory Form

1. Resource number: **5WL.7828** Parcel number(s):
2. Temporary resource no.: **N/A** **096105335009**
3. County: **Weld**
4. City: **Greeley**
5. Historic building name: **Sherman Auto Company Building, Shedd Auto Supply, Parr Auto Parts**
6. Current building name: **Smith Building**
7. Building address: **1019/1021 8th Avenue**
8. Owner name and address:

47. Photograph numbers: **CD #1; Images 5-9**
CD filed at: **City of Greeley Historic Preservation Office**
 1100 10th Street, No. 201
 Greeley, CO 80631
48. Report title: **Greeley 8th Avenue Comprehensive Historic Resource Survey**
49. Date(s): **November 30, 2015**
50. Recorder(s): **Carl McWilliams**
51. Organization: **Cultural Resource Historians**
52. Address: **1607 Dogwood Court, Fort Collins, CO 80525**
53. Phone number(s): **(970) 493-5270**

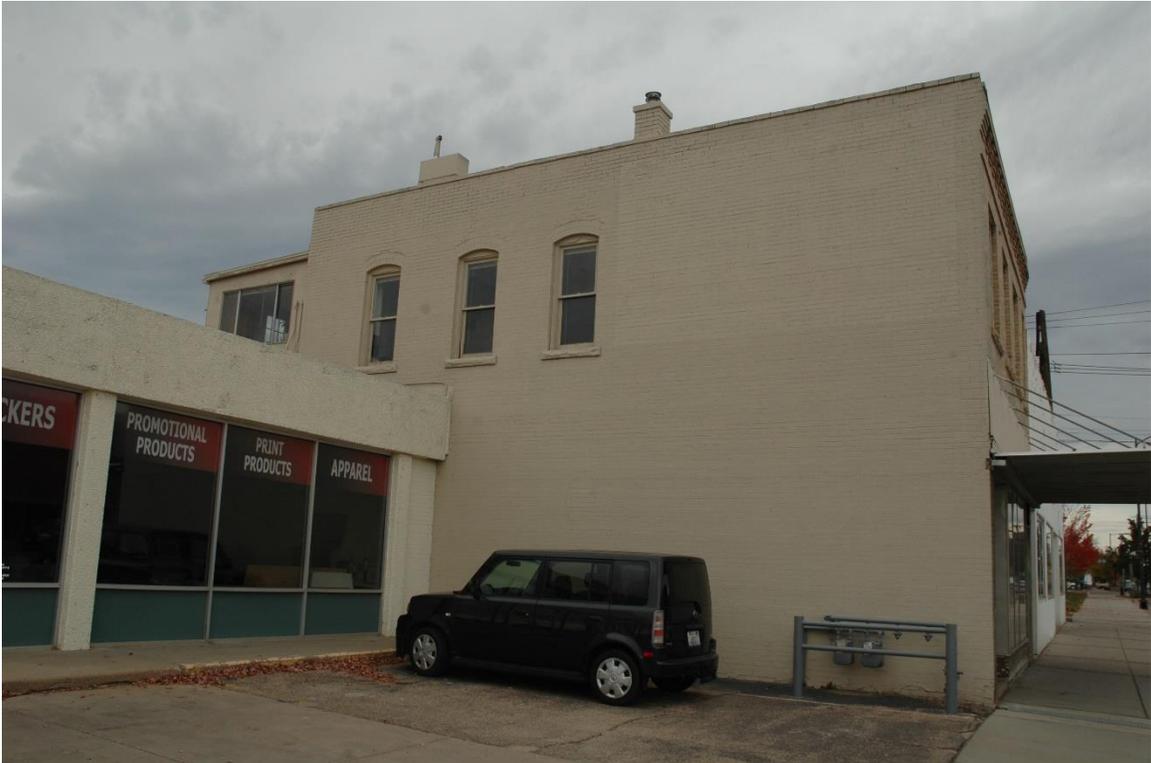
CD 1, Image 7, View to NNW of south side

running bond. The second story of the south-facing wall contains three narrow 1/1 sash windows with sandstone lugsills and segmental brick arches. The building's west-facing (rear) wall, and the exposed portion of the north-facing wall, are made of painted red brick laid in common bond. Three painted red brick buttresses, with sandstone caps, are located along the western end of the north-facing wall of the one-story section. A small shed-roofed second-story addition is located above the original one-story section, west of (behind) the original two-story section. A paneled door with nine upper sash lights opens from the second story addition onto the roof of the building's one story section.
