FACILITY CONDITION ASSESSMENT

CITY OF GREELEY
CPRD
2020 FACILITY ASSESSMENT

Final Report

CANNONDESIGN

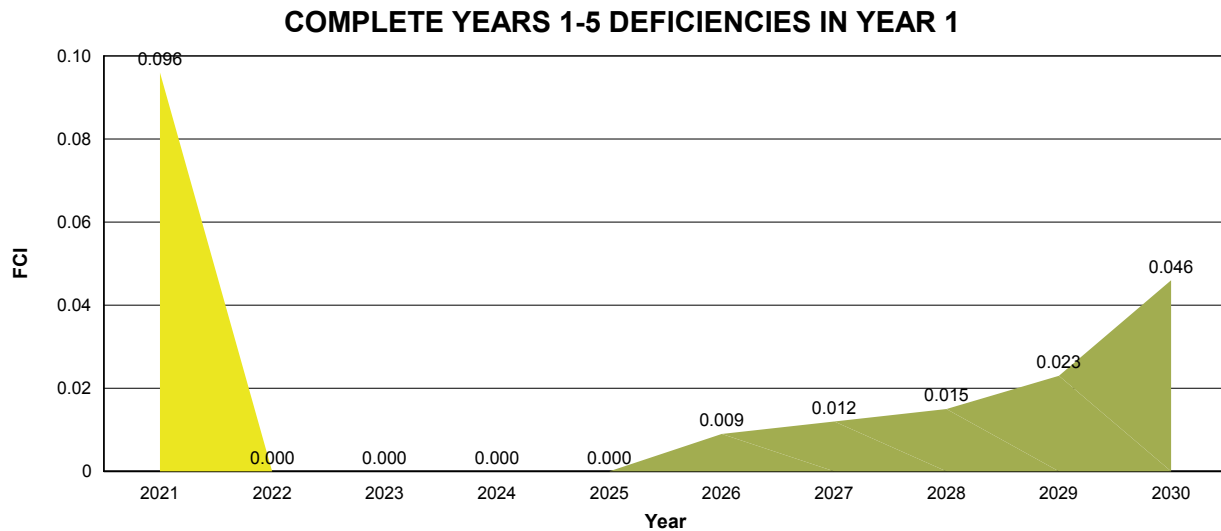
PROACTIVE STATE - RAPID IMPROVEMENT:

Summary: The below graph shows the current asset FCI Trend line after the entire 5-year needs are met in Year 1. This substantially reduces (improves) the 10-Year FCI score if funding is available.

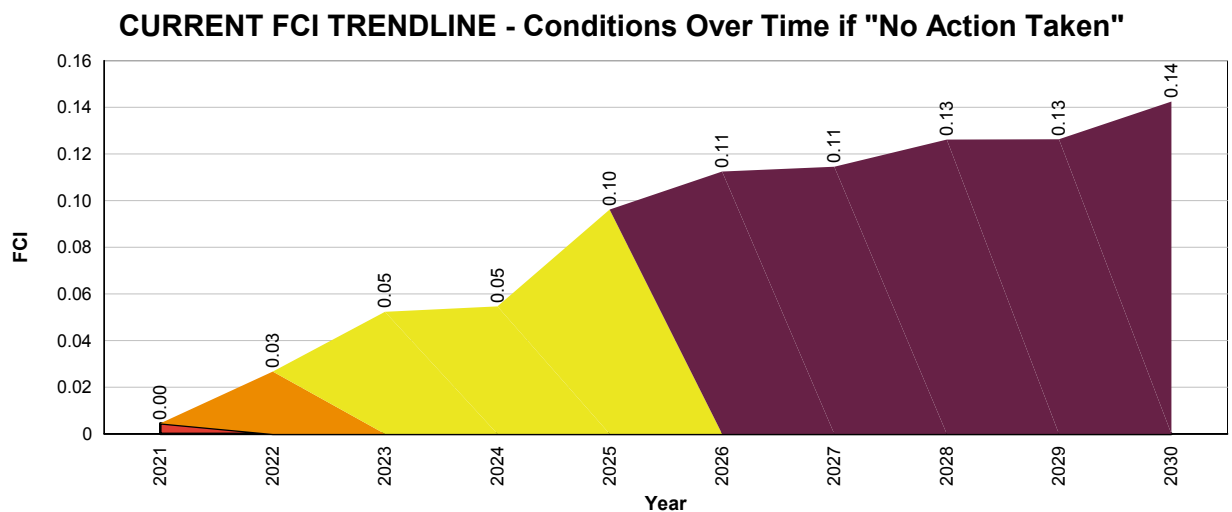
**FUTURE STATE - DO NOTHING:**

Summary: The below graph shows the current asset FCI Trend line projecting out to year 10. This shows the minimum potential of new 10-year needs awaiting the asset, and the subsequent increases in FCI.

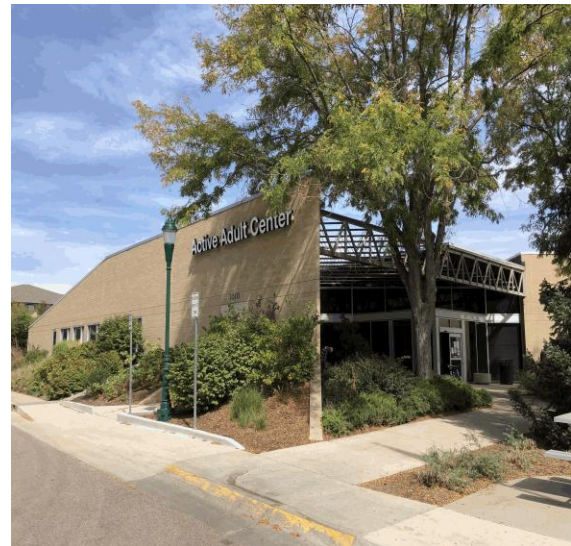
The Active Adult Center building, constructed in 1979, is a single-story building with a basement located at the corner of 10th Avenue and 6th Street. The facility is used for providing seniors with social events, group activities, and personal health assistance.

The building substructure components include cast-in-place foundations with spread footings and reinforced concrete floor slab. The exterior utilizes a steel column and beam structure. Roof structures consist of steel joists with composite metal decking.

The facility's exterior architectural vertical enclosure is comprised primarily of brick masonry veneer, with concrete masonry unit walls and accents. The exterior boasts exposed metal structural elements at the entrance to act as a decorative sunshade. Aluminum framed windows and storefront systems can be found throughout. Exterior doors and frames consist of aluminum frames with integral glazing and heavy-duty hardware and some metal utility doors and frames.

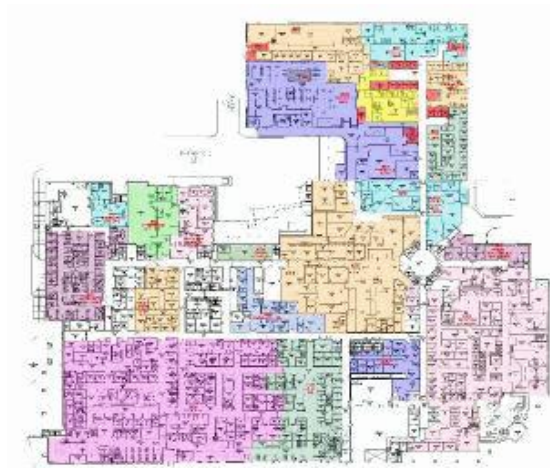
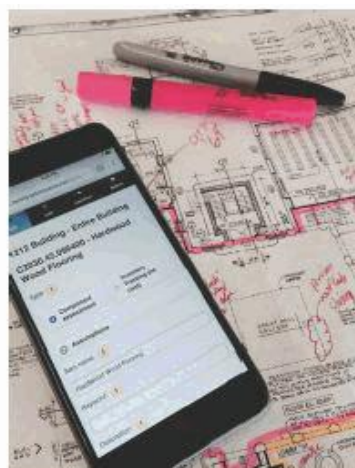
Data was collected and cataloged utilizing mobile electronic devices that transmit real-time information into our proprietary FOCUS™ software.

FOCUS™ is an industry-leading web-based facility condition assessment and management tool developed and maintained by CannonDesign's Facility Optimization Solutions group.
