## **HISTORIC PRESERVATION COMMISSION**

**PROJECT:** Window Replacement

814 19<sup>th</sup> Street, Camfield House

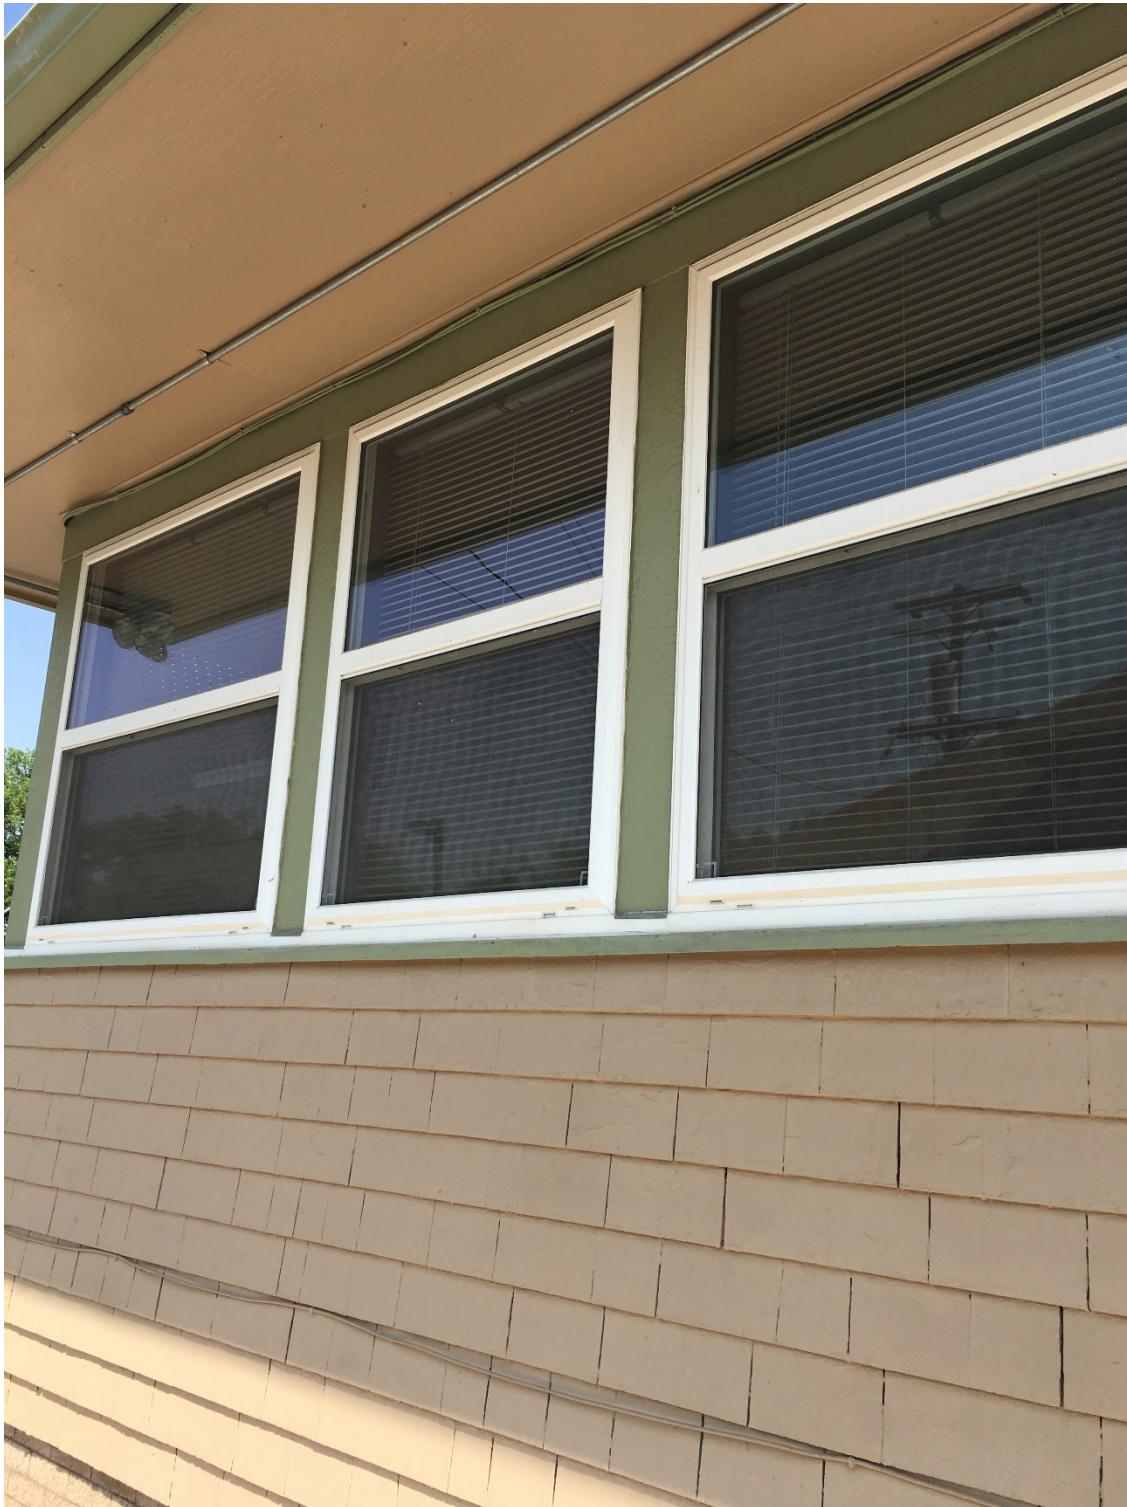
South windows, replaced April 2018

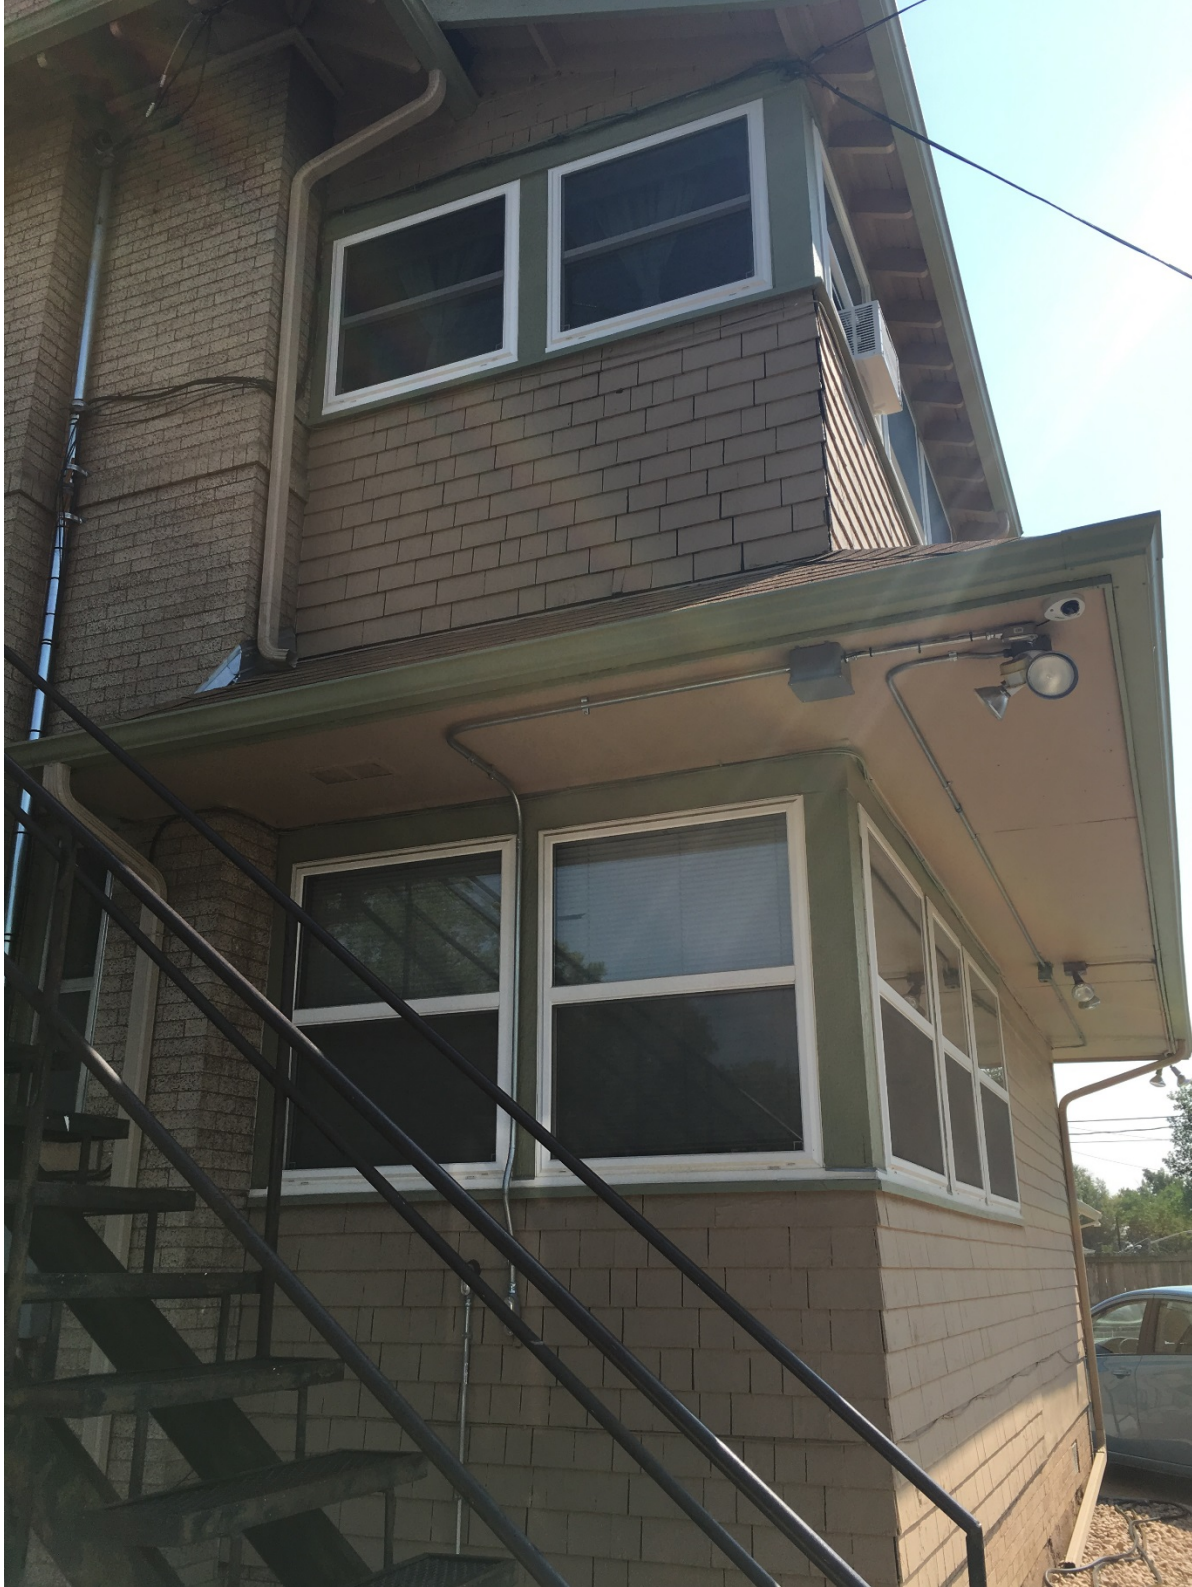
South windows, 2<sup>nd</sup> floor replaced April 2018; 1<sup>st</sup> floor replaced date unknown

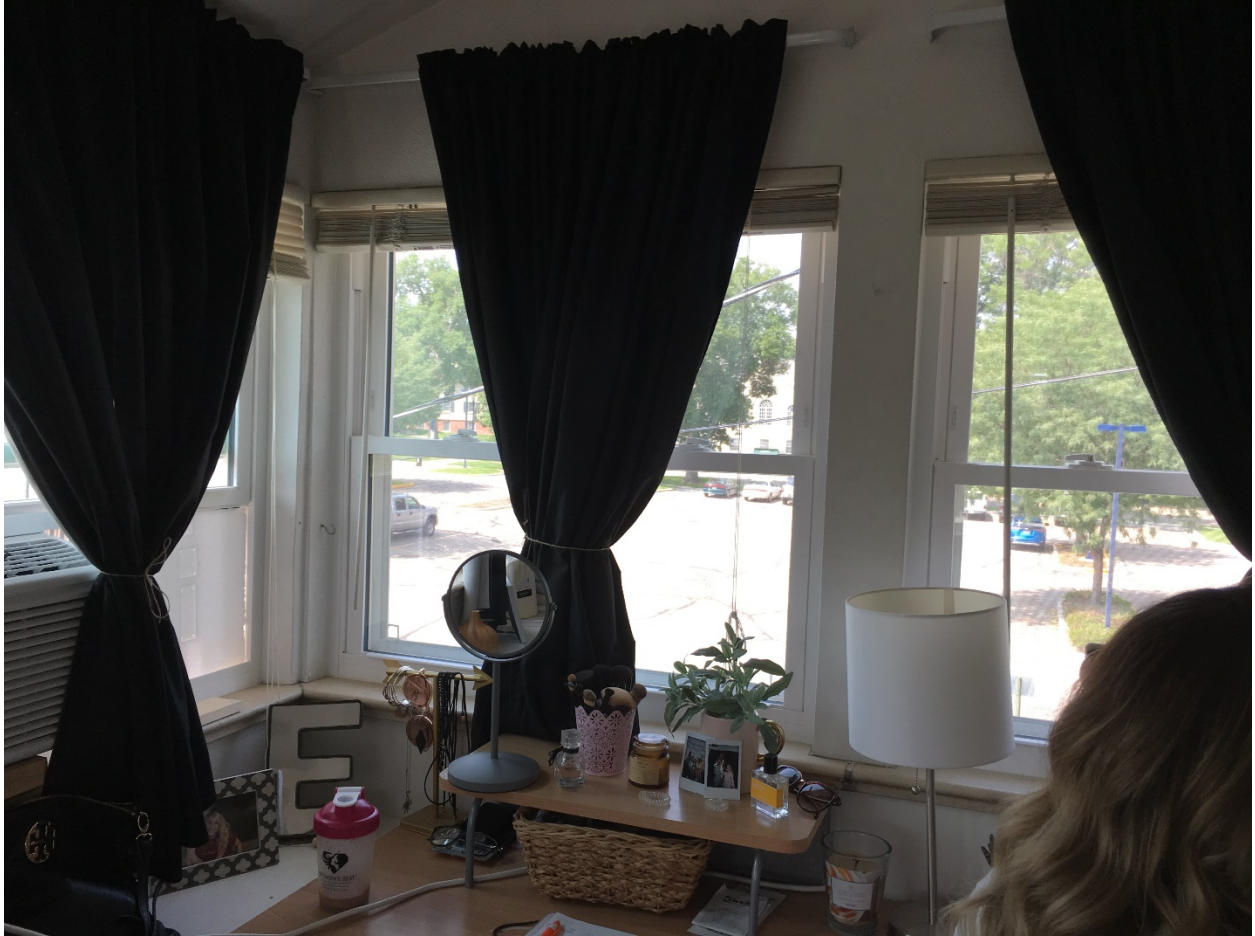
Interior view of Southwest windows, replaced April 2018

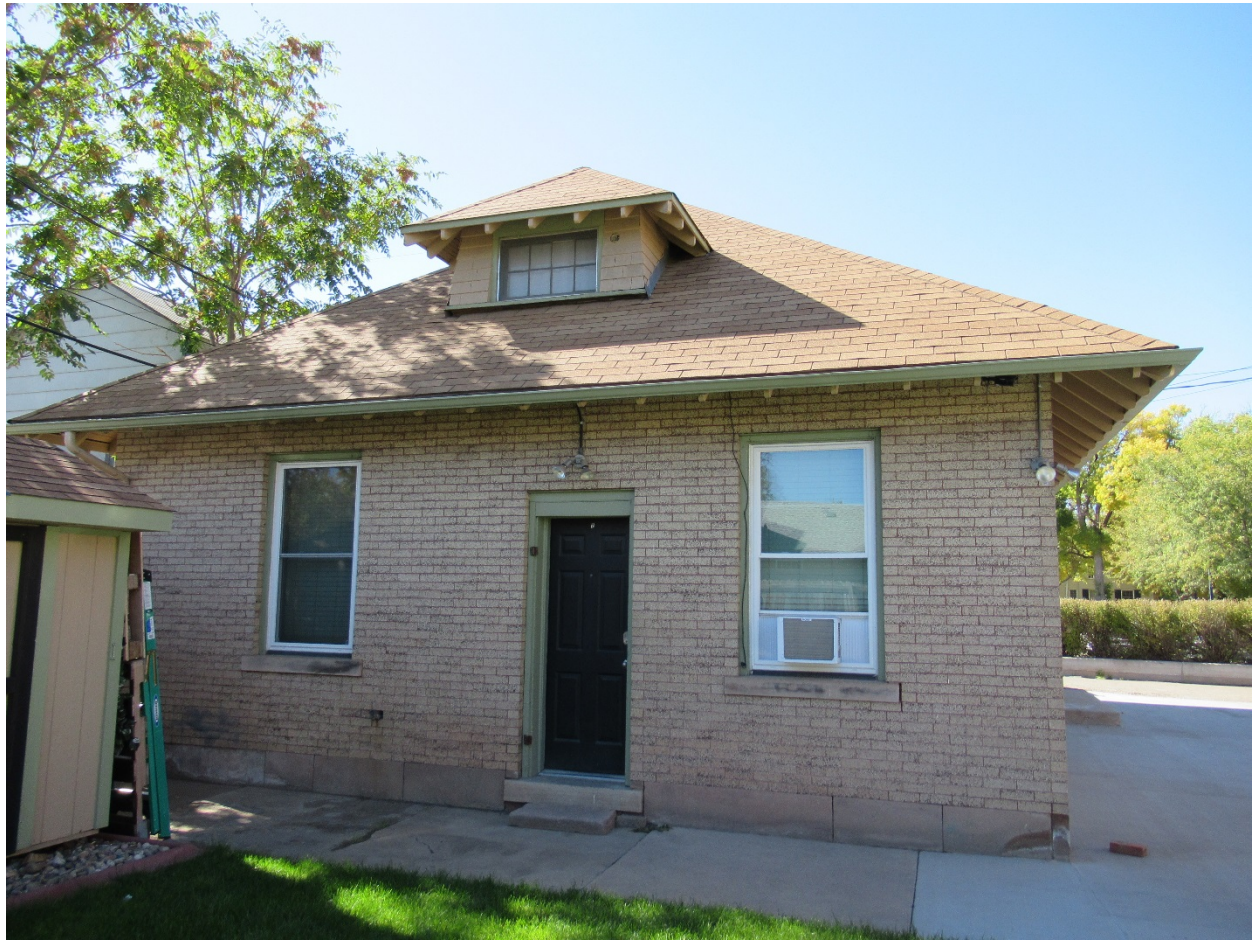
East side of the garage with two new windows

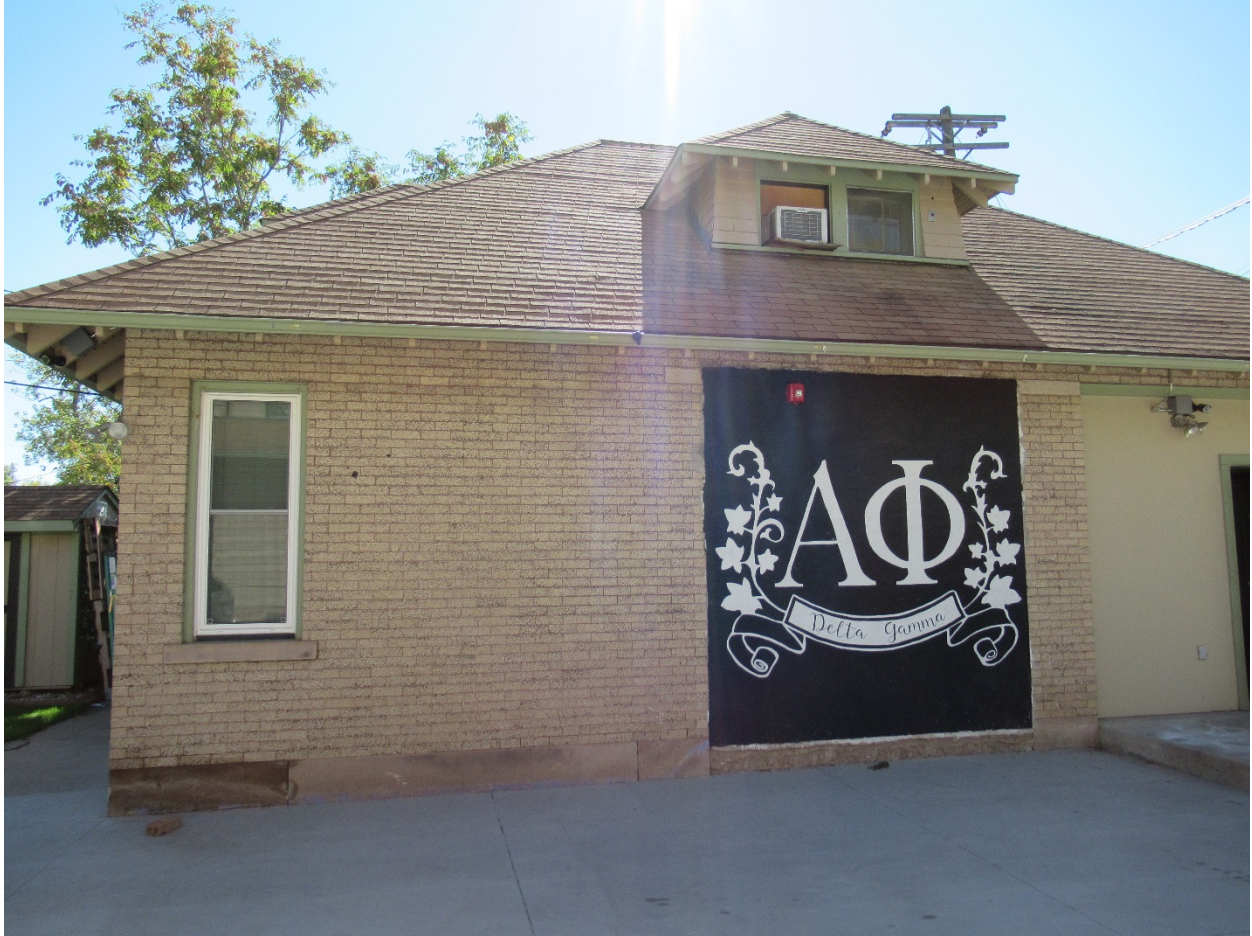
North side of the garage with new window

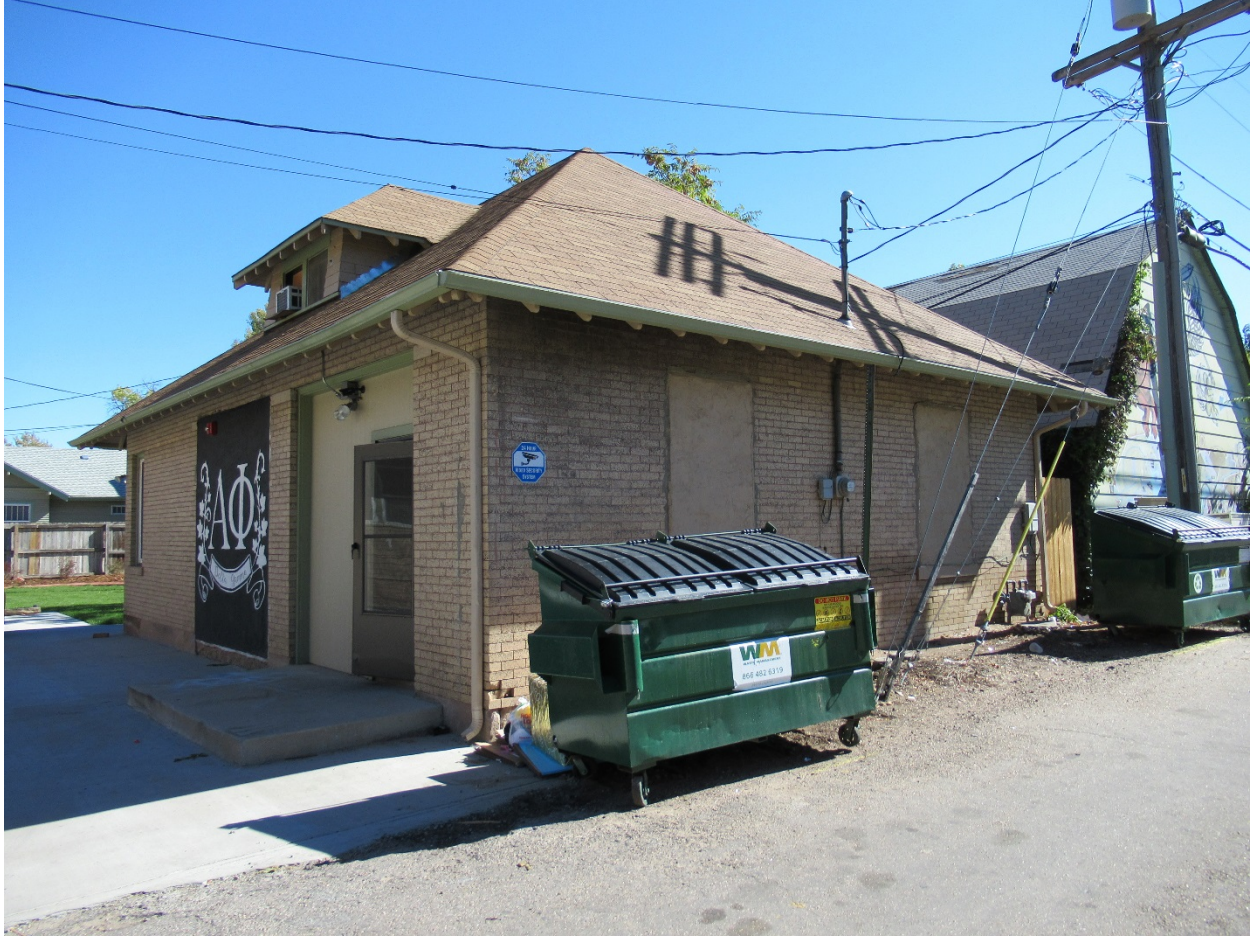
North and west side of garage; new window on far left of the building (see previous picture)

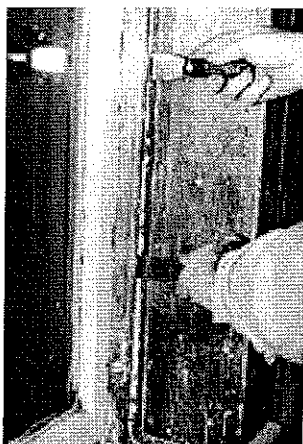
After removing paint from the seam between the interior stop and the jamb, the stop can be pried out and gradually worked loose using a pair of putty knives as shown. Photo: NPS files.

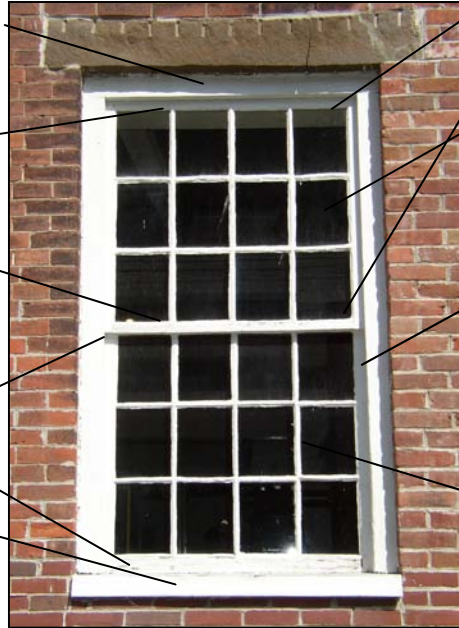
A c. 1846 wood window in the former Robins and Lawrence Armory, now the American Precision Museum in Windsor, VT.

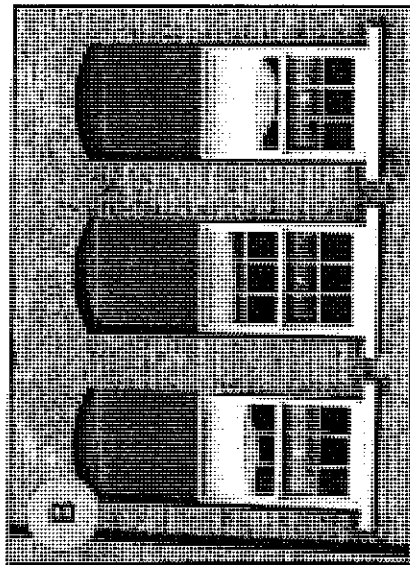
- A Italianate style row houses, side by side. Building to the right retains original arched one-over-one double-hung sash windows. Building to the left has smaller replacement windows and in-fill panels installed in the original opening.

- B Industrial building converted for housing with reduced windows and in-fill openings.
- C Main Street commercial building with upper floor windows removed, openings reduced down and much smaller replacement windows that do not match.

- D A stock, smaller window unit was used to replace a larger double-hung sash window.
- E Brick was used to in-fill the original opening of the round-arched window.

- F Two round arched windows were removed and replaced by one larger picture window, completely different in design and period to the historic Main Street building.

- G Three vertically-oriented Gothic style windows were reduced and replaced by horizontally-oriented hopper type windows.

Reducing or enlarging the window opening to accommodate a new replacement window is particularly harmful. It completely changes the entire proportions of a building, not to mention reducing daylight and potential air circulation. If you do choose to replace your original windows, do not eliminate window openings, in-fill or alter them to accommodate smaller or larger windows. These examples illustrate the dramatic change in appearance.

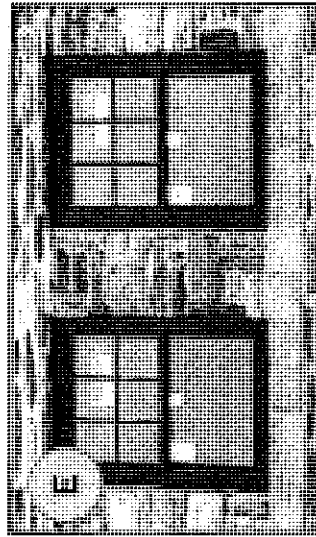
- B Modern interpretation of an arched window alters the pattern and overall design on this monumental civic building.
- C Replacing a round arched double-hung sash window is a one-over-one double-hung sash with fixed transom. This illustrates using stock windows to fit an opening that often requires a custom or more costly replacement window.

- E New windows will often require 'building out' and enlarging the casing and surround to accommodate a stock replacement unit, effectively reducing the size of the window in comparison to the originals.

- F The introduction of a hopper window completely alters the look of this window.
- G, H Window G features the original twenty-over-twenty double-hung sash window. The replacement, window H, is a fixed one-over-one unit. The design, profile and depth are altered in the process.

- I New windows attempt to replicate originals, though the casing and surround is wider and the fixed fanlight does not match originals.

Yes. Even when maintaining the original opening and general size of the old windows, replacement windows can sometimes miss the mark when details and overall design are off. To the greatest extent possible, new windows should match originals as closely as possible. These examples of replacement windows show how even subtle differences, even minor changes in design, can have an impact on the overall character of an older and historic building.

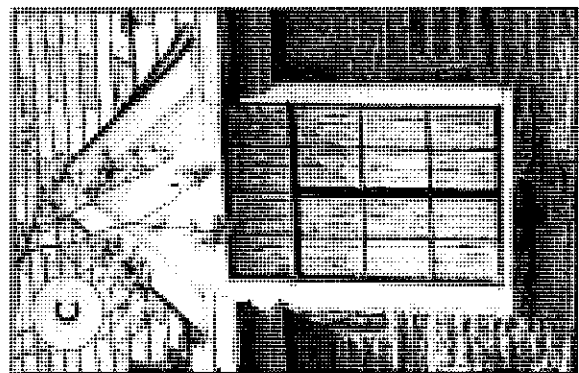
Two similar houses, both Tudor Revival style and dating to the 1920s or early 30s. Both featured steel casement windows, whereas only one retains the original windows today.

- A Steel casement windows with fixed transoms and side-lights, featuring interior storm windows. These windows are a character defining feature of the house.
- B Replacement windows attempt to match with casement style units yet the proportion, pattern, width and lack of a true divided-light miss the mark.
- C, D The differences between the original and replacement are readily seen, where the wider casing and surround are much prominent on the replacement windows.

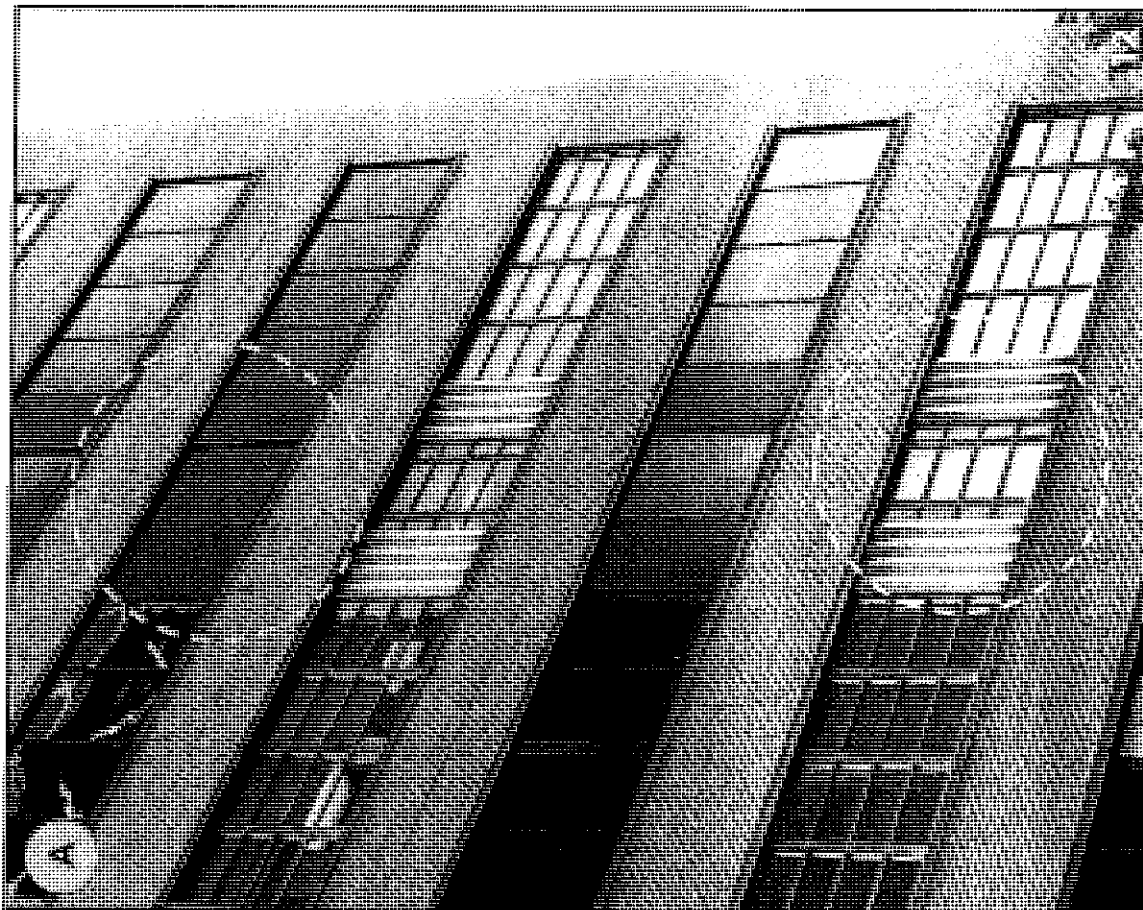
### CASE STUDY: A Modern Dilemma

Buildings dating to the second half of the 20th century challenged earlier architectural practices and design, featuring experimental materials and introducing new concepts, such as the 'picture window.' Today, some of these materials are failing, difficult to maintain, and may fall short of optimal energy efficiency goals. As important character-defining features, repair is optimal as finding replacements that match will be difficult. These examples illustrate the challenges.

- A Original, character defining windows and corrugated stainless steel detail are being removed on this 1950s office building, replaced by dark tinted fixed windows that do not match.
- B, C Large spans of single pane and plate glass require innovative solutions, such as custom designed storm windows.
