W. 10th Street Commercial Corridor Conditions Survey Plus

W. 10th Street Commercial Corridor Urban Design Plan Elements

West 10th Street Corridor

Urban Design Plan Elements

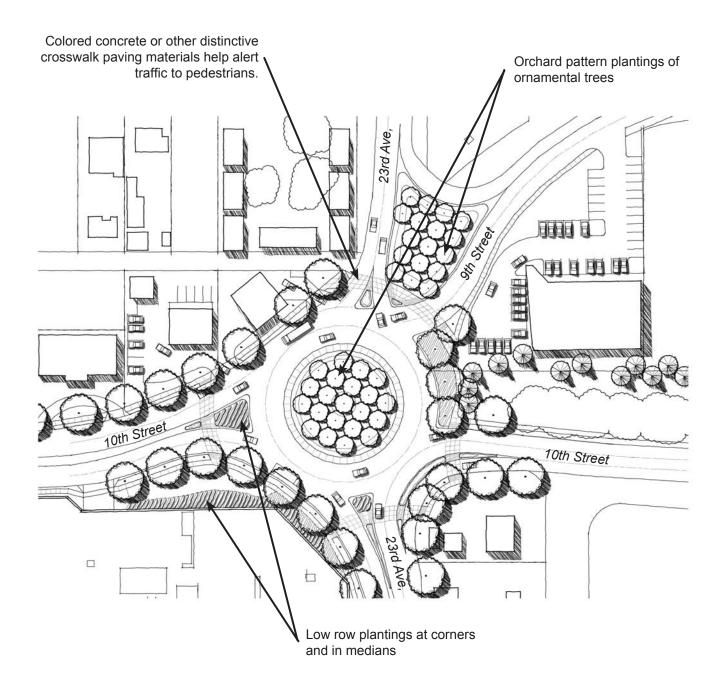
WEST CORRIDOR GATEWAY CONCEPT

The corridor gateway establishes the thematic entry statement to the West 10th Street Corridor. The enhanced landscape, hardscape, monument signage, and lighting all play a part in setting the stage for what is to come.

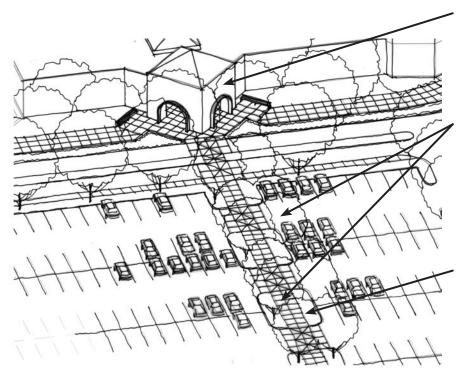
Breezeway through buildings for pedestrian connections

Pedestrian connectivity through parking lots provides direct links to buildings, parking, and surrounding neighborhoods.

Architectural and site details reflect a pedestrian scale; may include awnings, banners, street trees, and benches

Potential location for thematic panel to add interest to streetscape and provide additional safety for pedestrians.

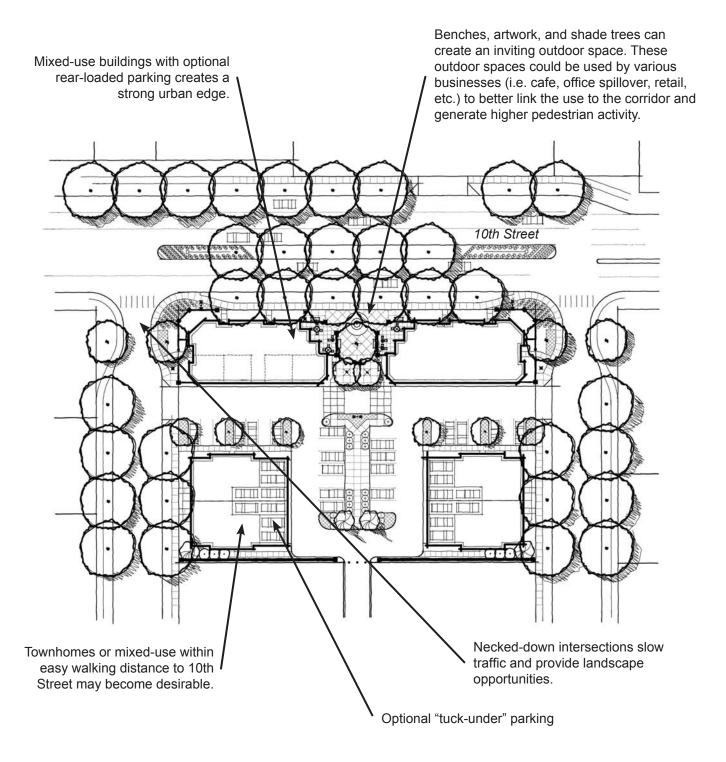
SECONDARY NODE - INTERSECTION

Pedestrian friendly intersections with amenities may reduce reliance on vehicles and will increase pedestrian opportunities.

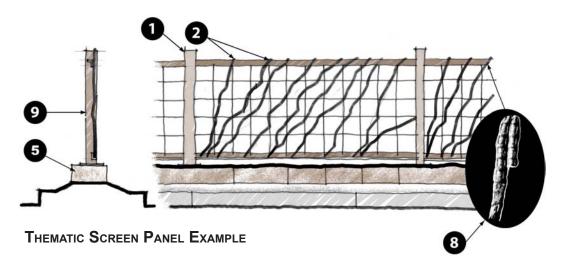
Each panel is a Corten steel frame with a heavy gauge, welded wire mesh backing. Rebar bent and welded to the panel represents prairie grass blowing in the wind.

Starting at the narrow end portions of a typical median, the fence panels extend inward toward the, running a variety of distances. When median widths increase beyond 6', the fence terminates at an architectural column, shown in masonry or alternative steel forms. The widest portion of the median is reserved for landscaping. These panels will add visual interest to the corridor and tie the corridor theme to the streetscape. Panels may also be used as a visual barrier along walks (see 'Detached Sidewalk' exhibit).

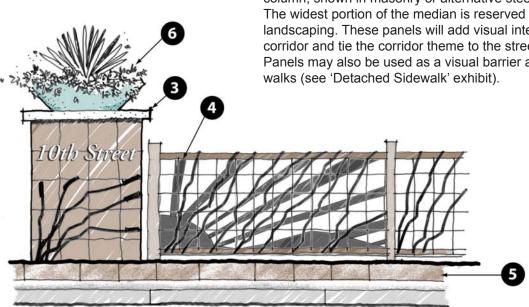
THEMATIC SCREEN PANEL & MASONRY COLUMN EXAMPLE

THEMATIC PANEL & COLUMN KEY

- (1) Corten steel frame fence with 6" welded wire mesh backing (fence panel: 3'x6')
- (2) #5 rebar, welded and bent to form "prairie grass" pattern
- (3) 2 ½' x 2 ½' x 3 ½' color masonry column with rebar grass patterns on nose and street side faces. Masonry color to compliment the Corten steel fence.
- (4) Plasma cut "sun/ray" plate Corten steel pattern at end panel
- (5) Color concrete fence pedestal
- (6) Concrete planter with "Greeley Green" acid stain
- (7) Corten steel frame column with welded wire mesh vertical faces, and grass rebar patterns on nose and street side faces. Translucent "Greeley Green" Lexon cap with uplight at column base.
- (8) Welded rebar seed cap
- (9) Fence panel end view includes: 4" Corten steel post, #5 rebar, welded wire mesh between "L" angle Corten steel top and bottom runners; fence panel surface mounted to color concrete base

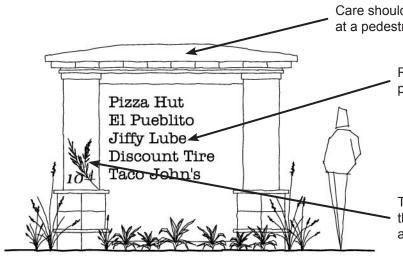
Typical Large Monument Sign Character Example

Care should be taken to keep the height of the sign at a pedestrian scale.

Retail lettering may be consistent to promote the corridor's theme.

The corridor theme can be represented through small attached or etched emblems and sign materials.

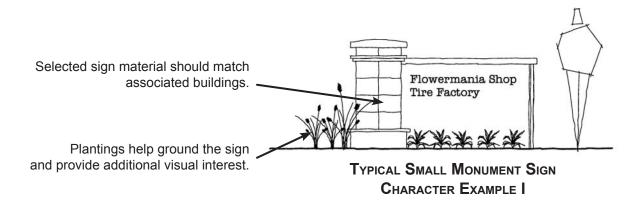
Typical Small Monument Sign Character Example II

Signage may be individual or shared among neighboring businesses.

Substantial sign foundations help to anchor the monument to the ground plane.

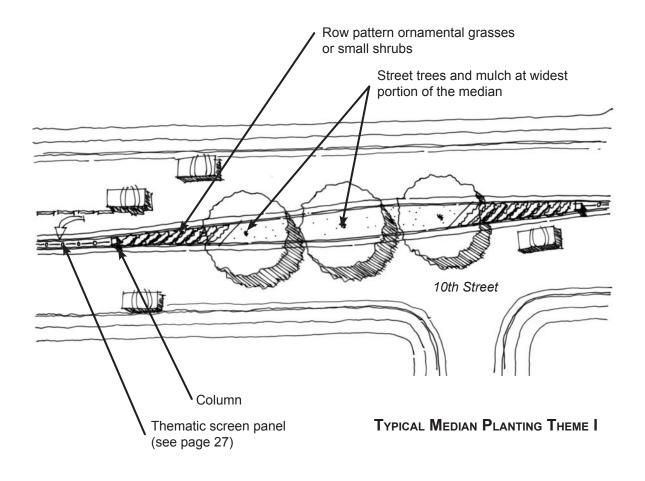
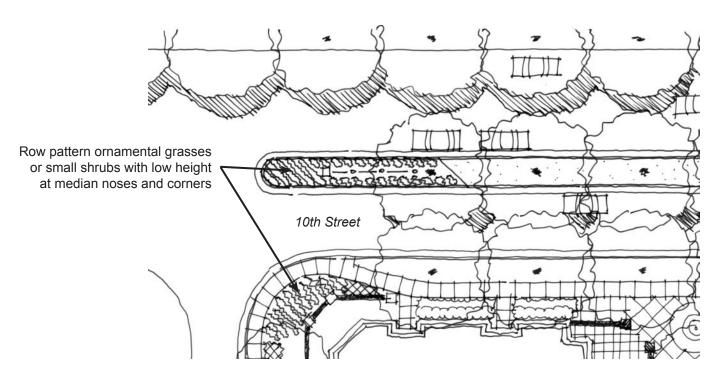
TYPICAL MEDIAN PLANTING THEME II

Row pattern perpendicular to the primary sight line

Landscape Enhancements - In special focal areas such as gateway entries and primary or secondary nodes, enhanced landscaping in the form of additional shrubs, annuals, and perennials should be used. In medians 6' or wider, low maintenance landscaping such as shrubs, perennials, or groundcovers are recommended. In accordance with the theme of "blades of grass", native grasses should be incorporated into the design where possible

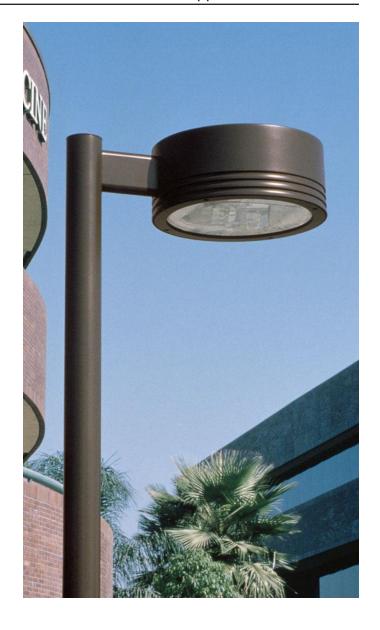
Design Element: Pedestrian Light

Mounting Height: 30' Pole Height: 30'

Color: Custom - Greeley Green

Model: Largent

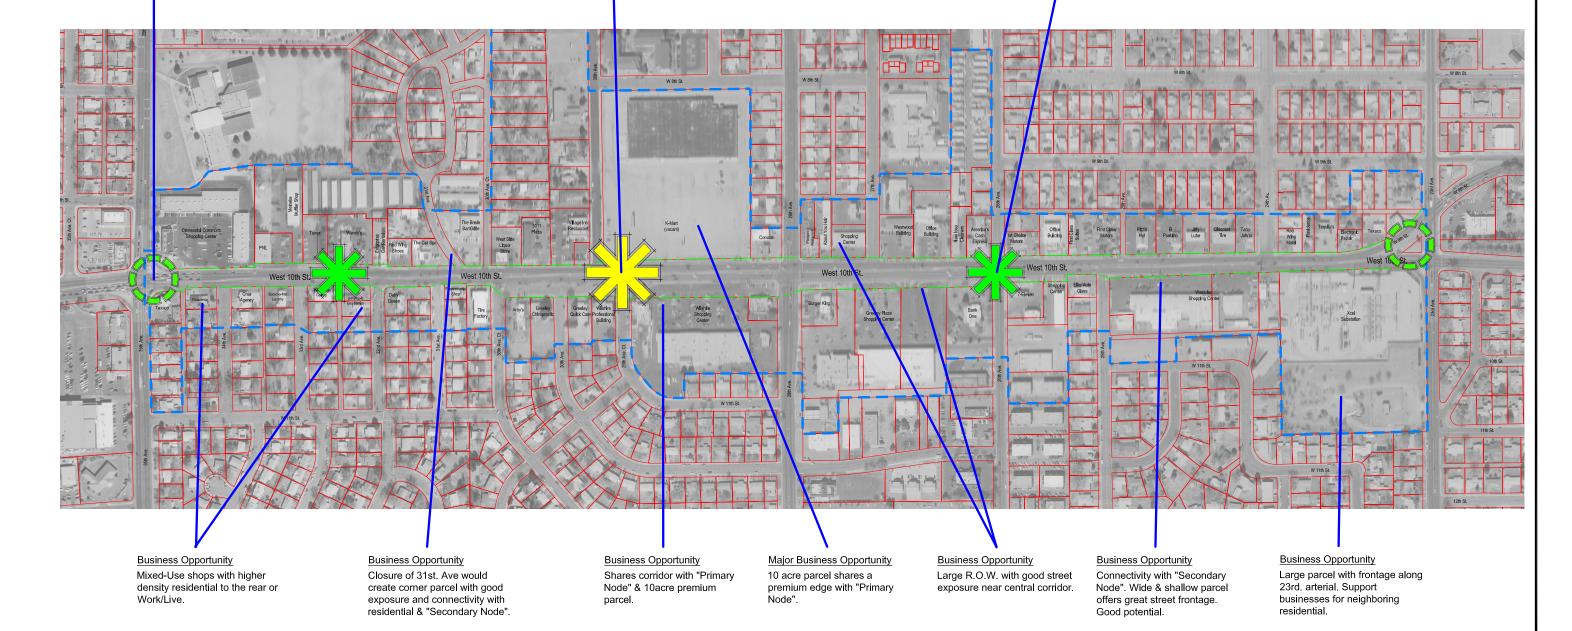
West 10th Street Corridor Map

Secondary Node

- -Pedestrian Connection
- -Landscape Features (ex.bollards; enhanced paving; seating walls; small artwork; etc.)
- -Unifying design elements
- -Opportunity to "re-emphasize" corridor theme.
